ACCIDENT INVESTIGATION REPORT
(UNDERGROUND COAL MINE)
NON-FATAL COAL OUTBURST ACCIDENT
NO. 37 MINE (I.D. NO. 15-04670)
ARCH OF KENTUCKY, INCORPORATED
CUMBERLAND, HARLAN COUNTY, KENTUCKY

JANUARY 11, 1991

REPORT OF INVESTIGATION
(UNDERGROUND COAL MINE)

NON-FATAL COAL OUTBURST ACCIDENT
NO. 37 MINE (I.D. NO. 15-04670)
ARCH OF KENTUCKY, INCORPORATED

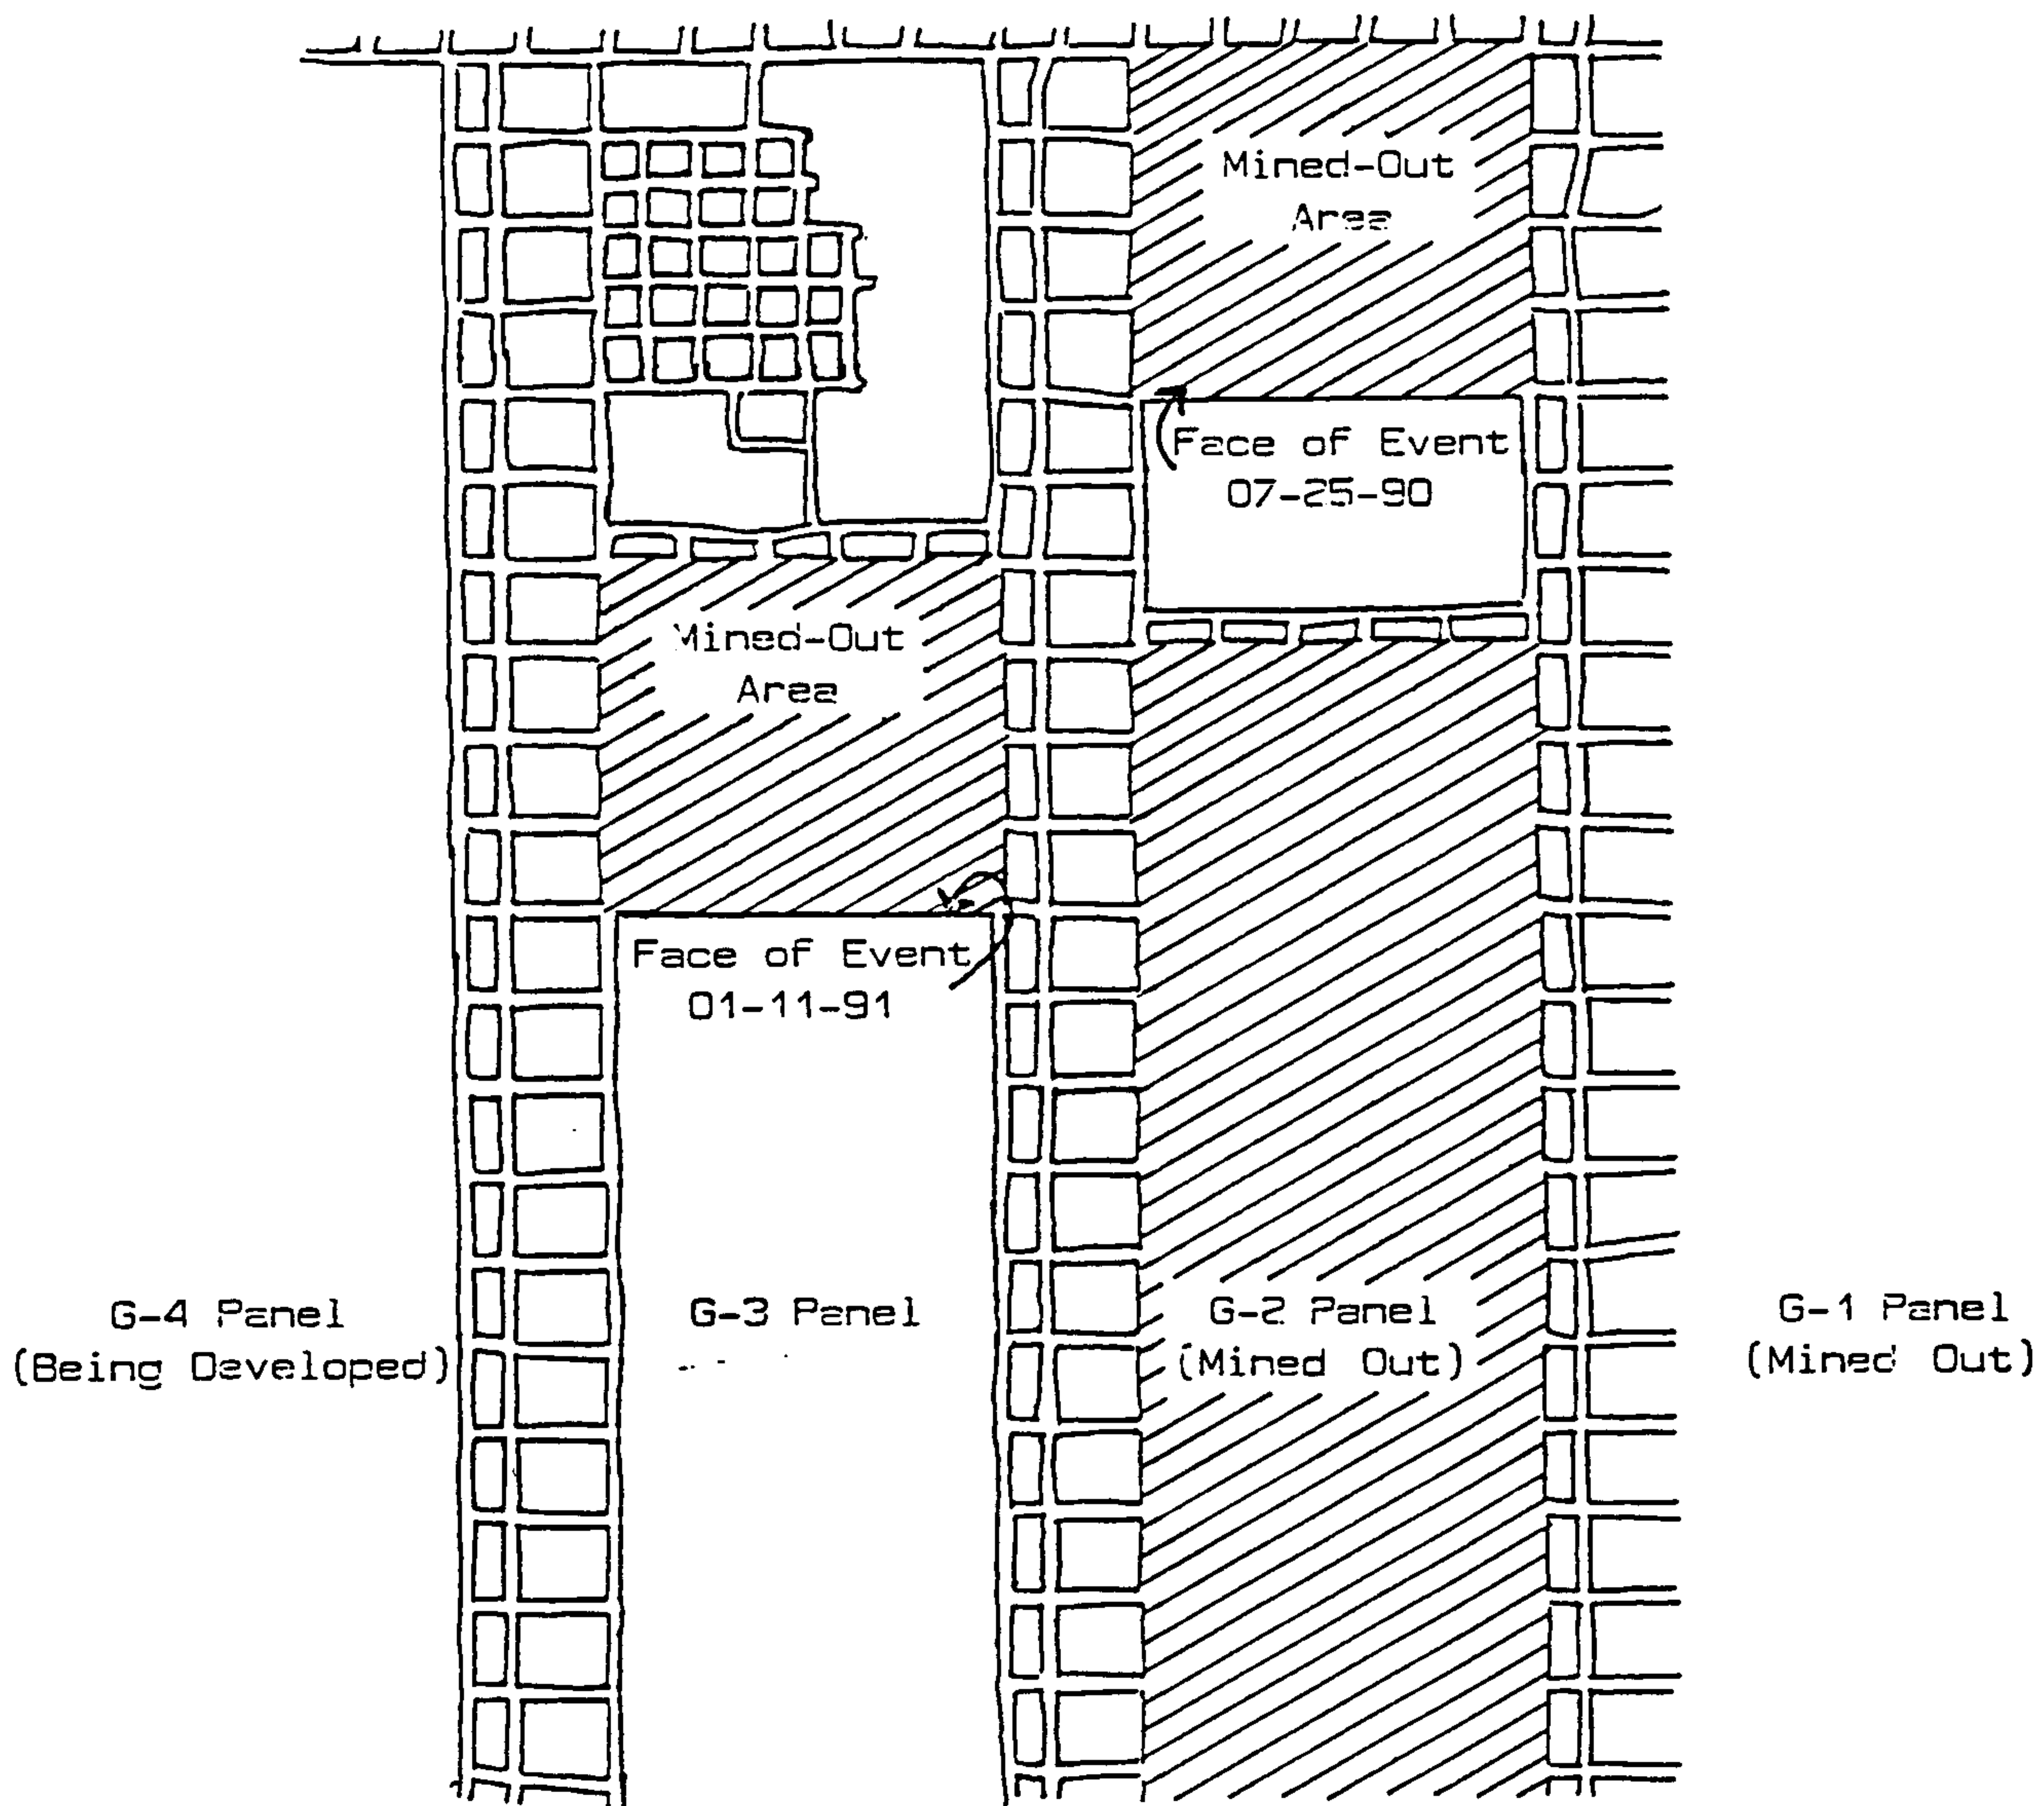
MULTIPLE NONFATAL INJURY COAL OUTBURST ACCIDENT
 NO. 37 MINE (I.D. NO. 15-04670)
 ARCH OF KENTUCKY, INCORPORATED
 CUMBERLAND, HARLAN COUNTY, KENTUCKY
 JANUARY 11, 1991

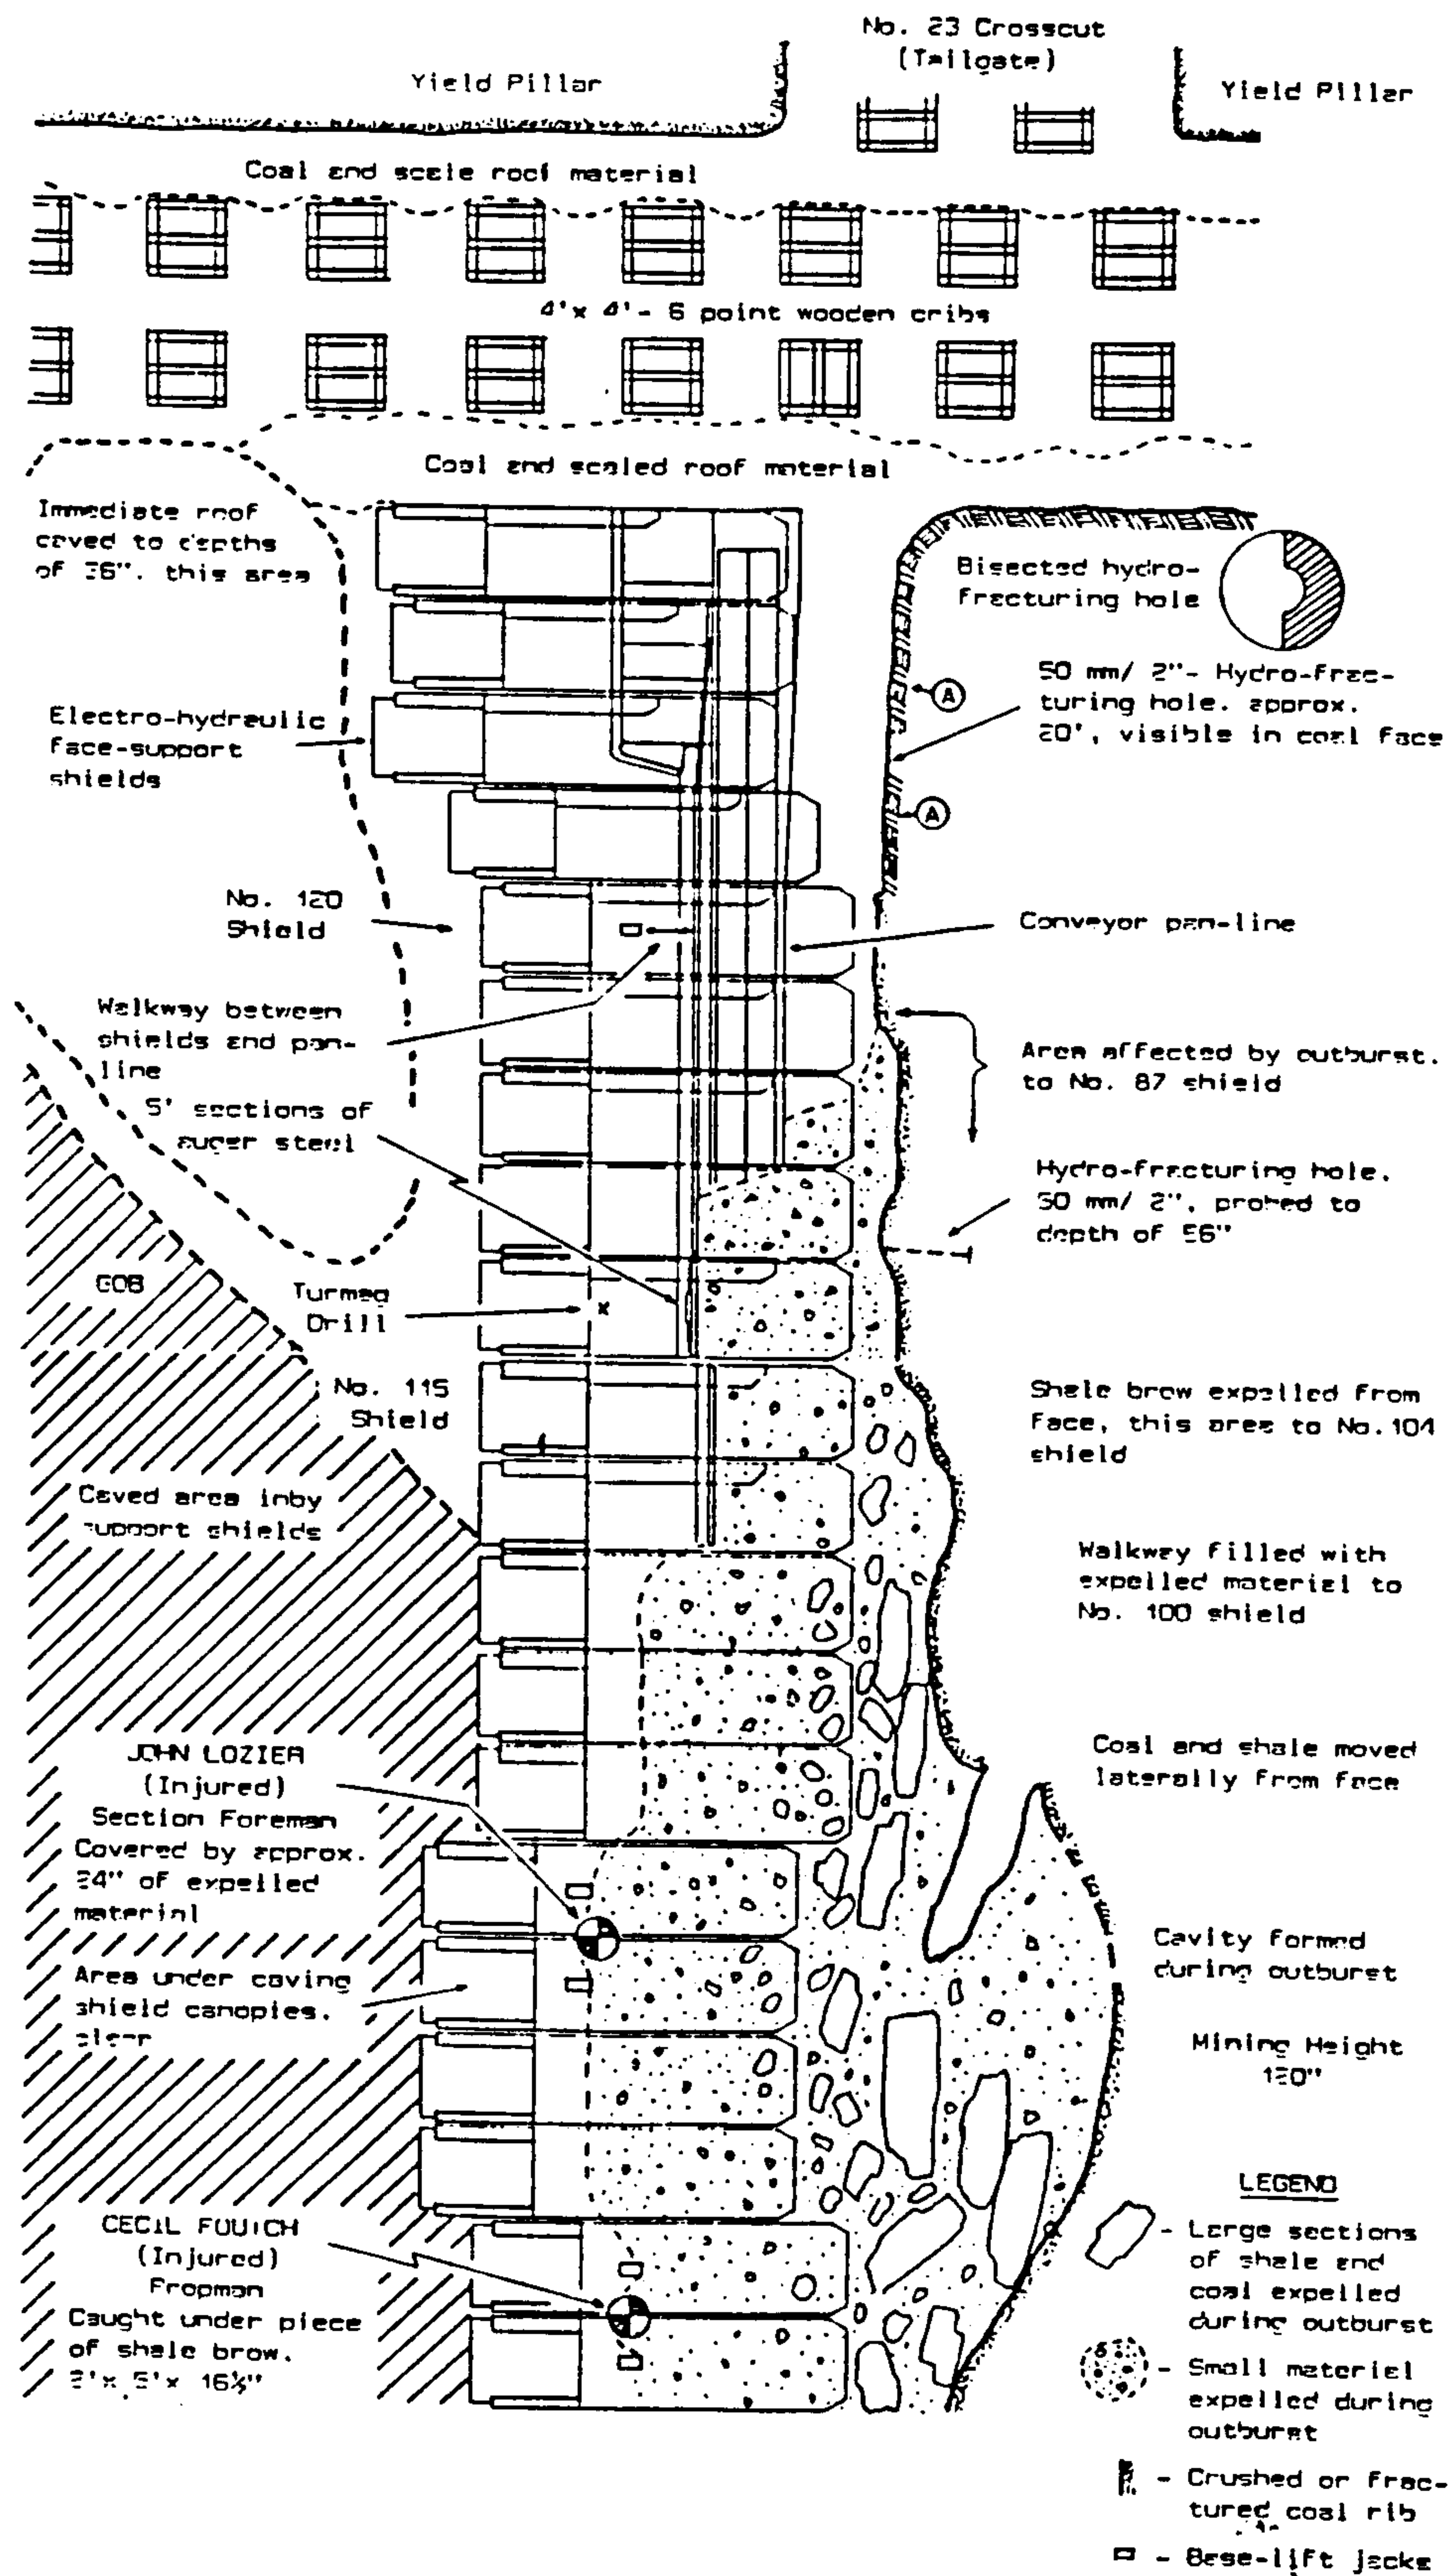
Drawing 1

MULTIPLE NONFATAL INJURY COAL OUTBURST ACCIDENT
 NO. 27 MINE (I.D. NO. 15-04670)
 ARCH OF KENTUCKY, INCORPORATED
 CUMBERLAND, HARLAN COUNTY, KENTUCKY
 JANUARY 11, 1991

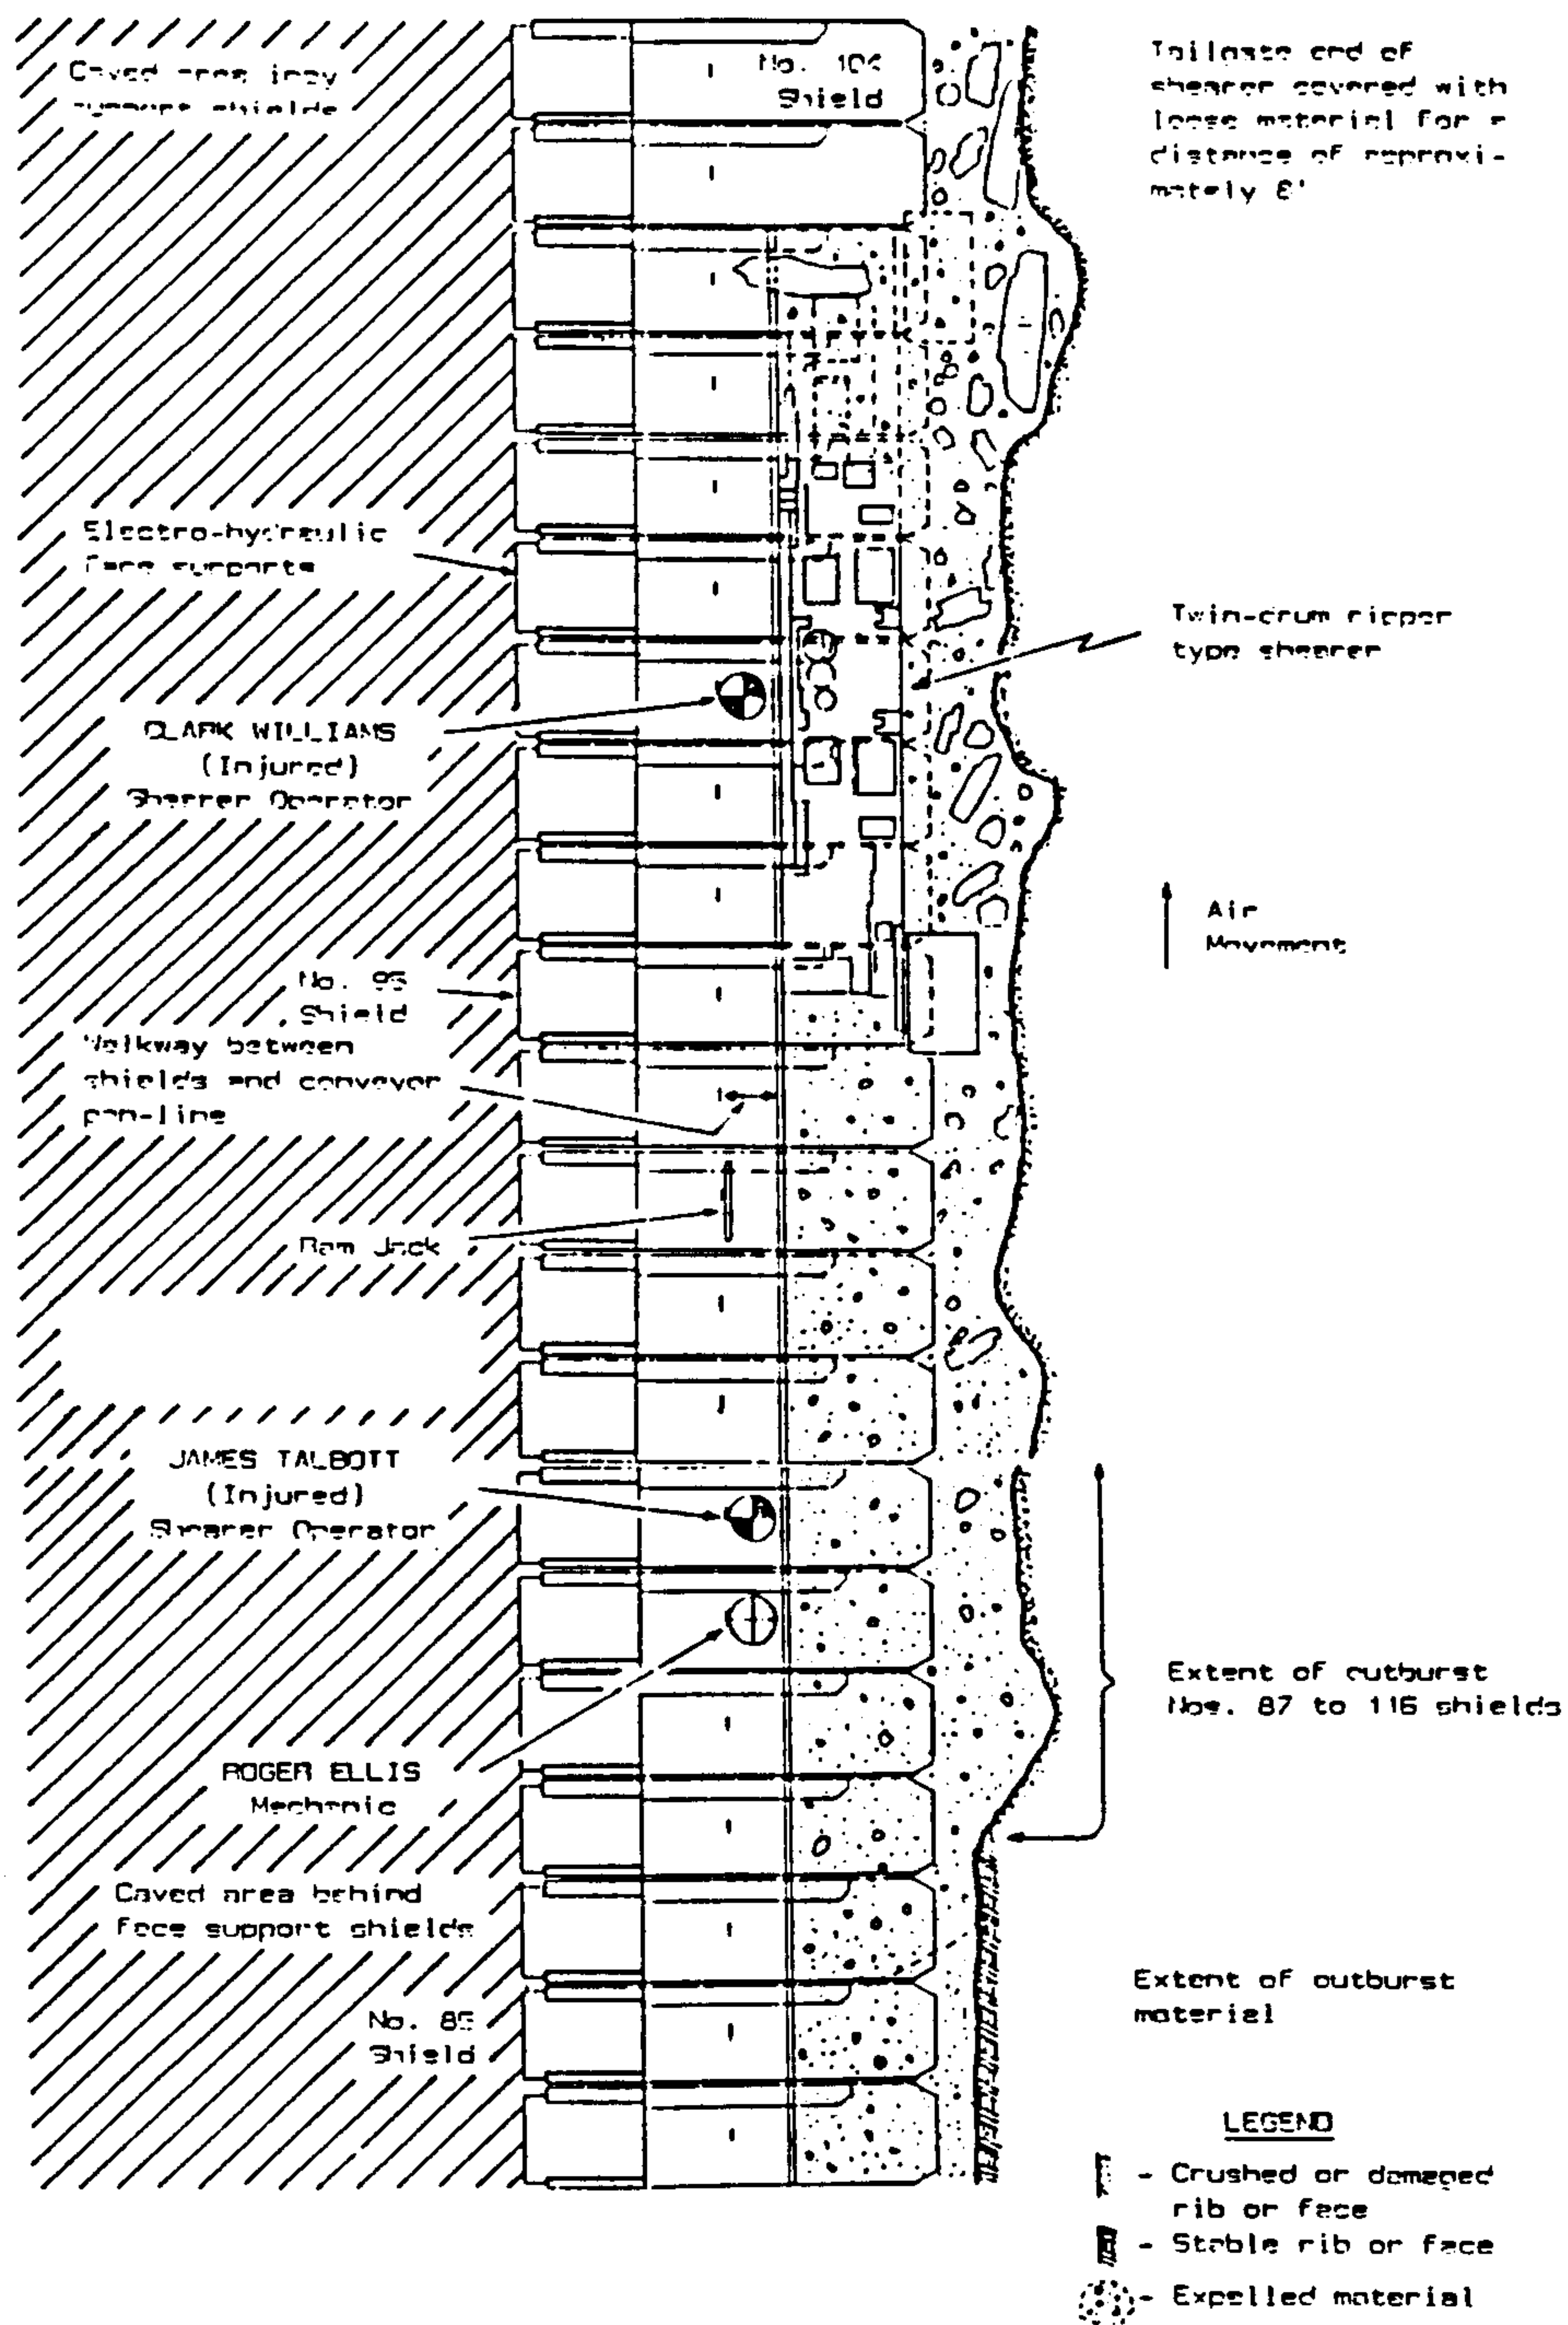
Drawing 2

MULTIPLE NONFATAL INJURY COAL OUTBURST ACCIDENT
NO. 37 MINE (I.D. NO. 15-04670)
ANCH OF KENTUCKY, INCORPORATED
CUMBERLAND, HANLAN COUNTY, KENTUCKY
JANUARY 11, 1991
